MISSE-6 Post-Flight Examination, Disassembly and Analysis Results

**Report submitted to Air Force Office of
Scientific Research
Contract FA9550-09-C-0206**

FINAL REPORT

Post Flight Inspection and Test Results for MISSE-6 Power Distribution System and Boeing Experiment Data Wiring.

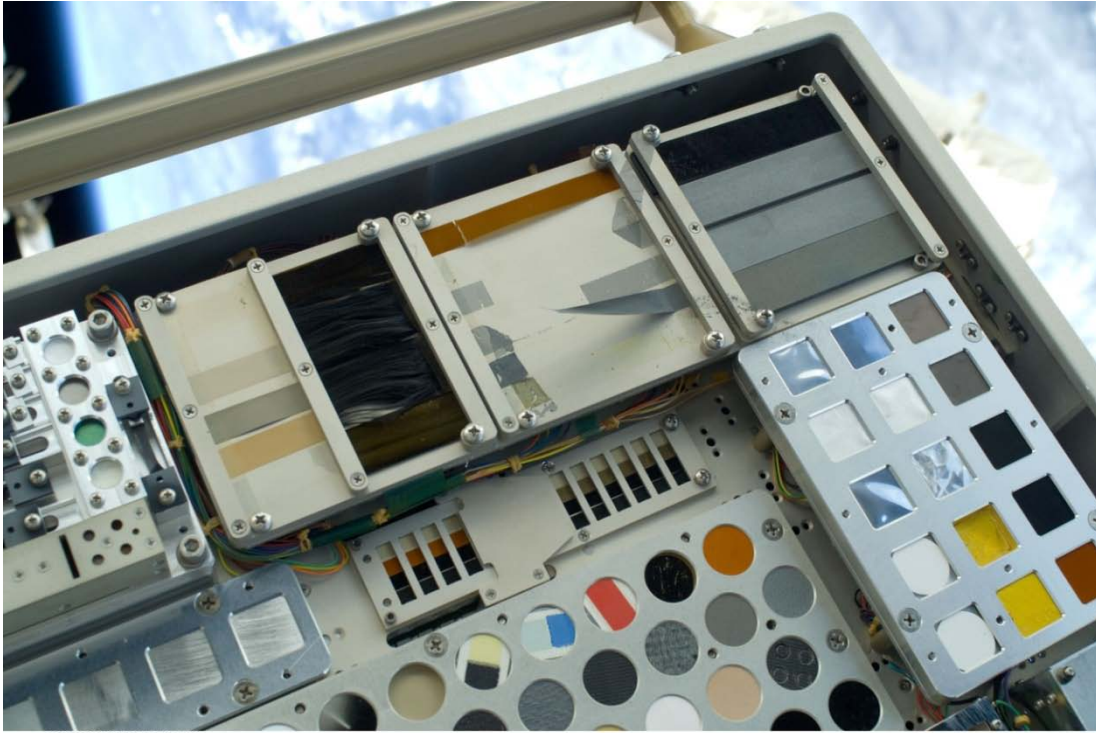
Figures 4 through 11 are close-up images taken on-orbit following the 17 month exposure. Damage to particular specimens is evident in Figure 9, which shows failed thin film specimens on the Ram (AO/UV) side of MISSE-6B. Post-flight, the ram side of MISSE-6B generally showed the most visible damage. Virtually all specimens on the “wake” (UV exposed) side of both 6A and 6B were intact and looked in reasonable condition post-flight.

Figure 9. MISSE-6B AO/UV side on-orbit, showing damage to thin films (NASA image).

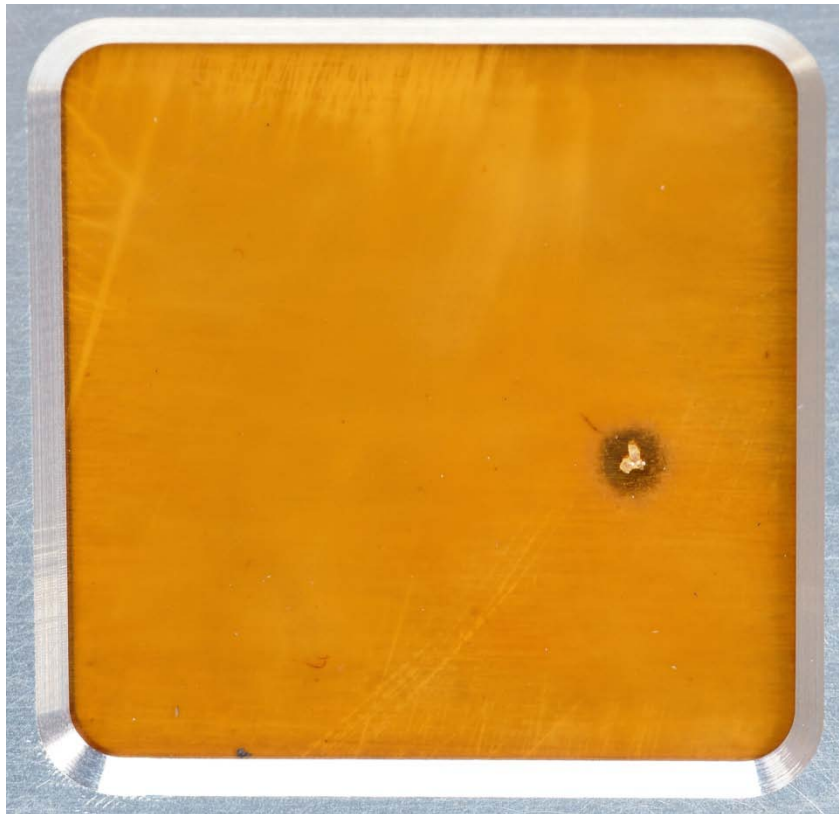
Figure 16. Impact in thin film specimen from MISSE-6 (NASA image).

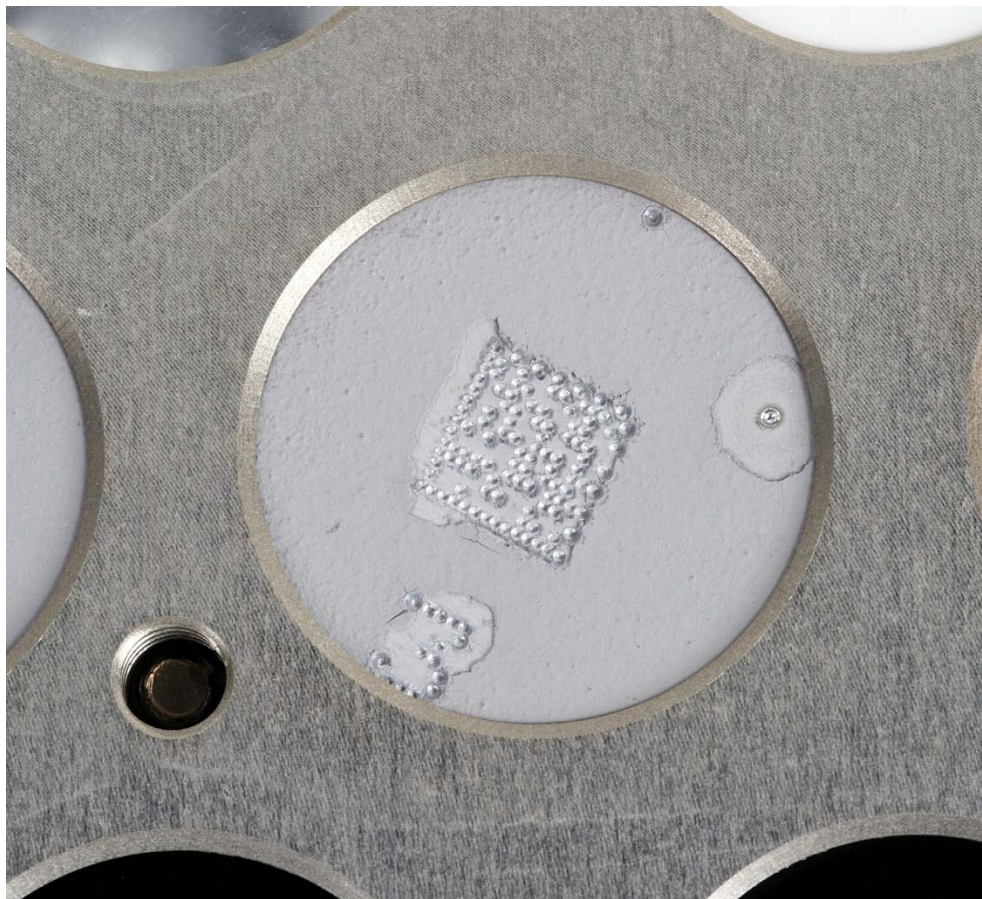
Figure 17. Impact on specimen from MISSE-6 (NASA image).

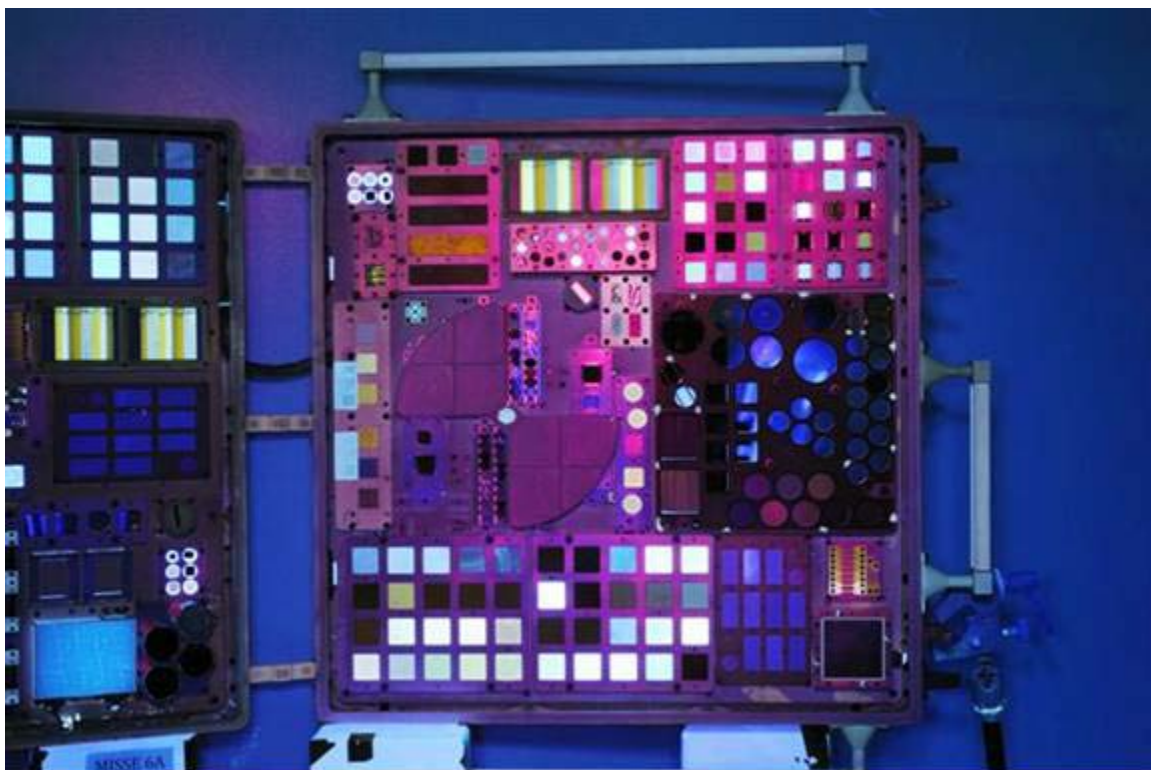
Visual inspection of both MISSE-6A and MISSE-6B did not reveal any obvious molecular contamination. These observations were supported by inspections under black light, which also showed the surfaces to be generally clean. Representative black light images for MISSE-6A are shown in Figures 19 and 20. Results from MISSE-6B are similar.

Figure 19. Black light image of MISSE-6A ram-facing surface.

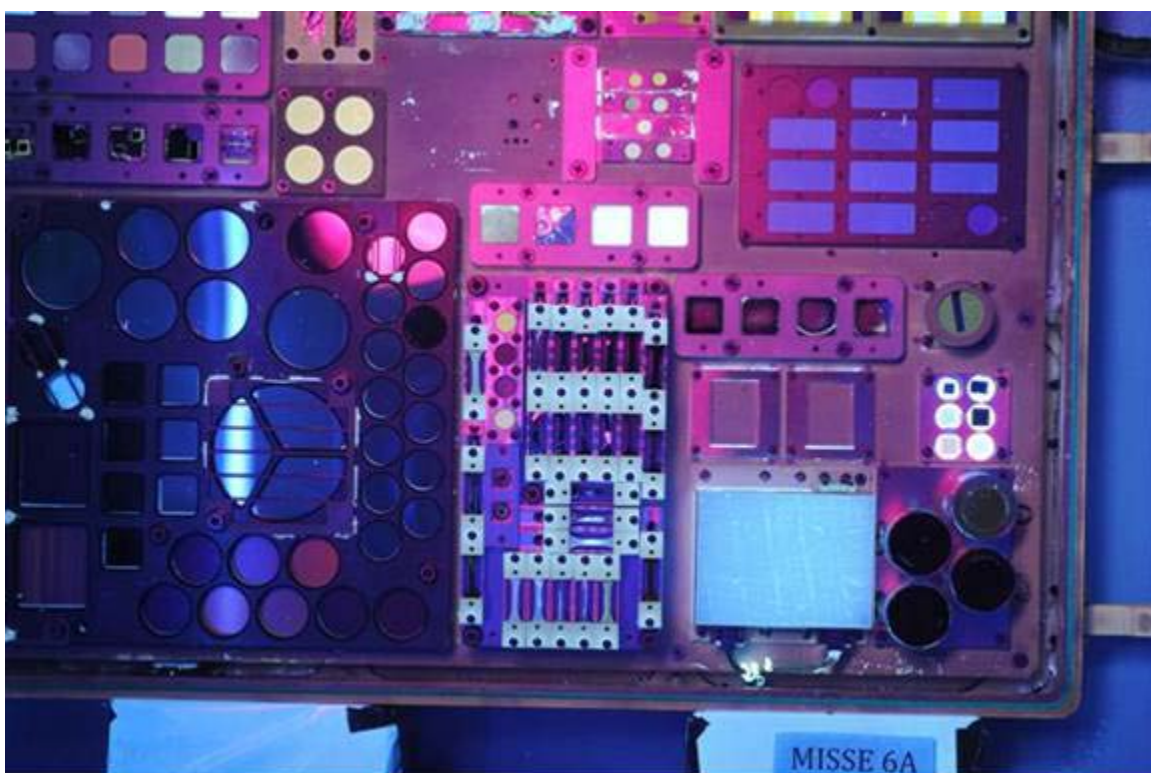
Figure 20. Black light image of MISSE-6A wake-facing surface.

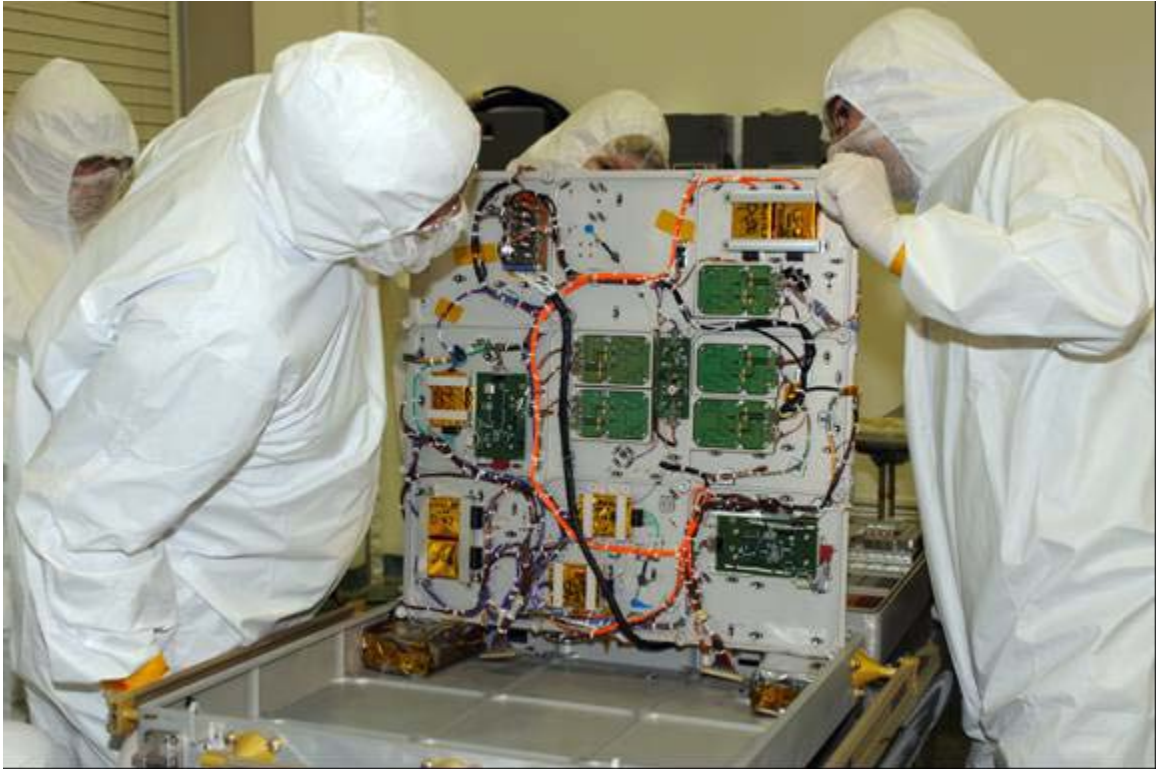
Figure 27. Inspection of MISSE-6B tray from the ram-facing side, post-flight (NASA Image).

The underside of the tray and hardware are in good condition post-flight. As with previous MISSE flights, the silver-coated nut plates are significantly oxidized.

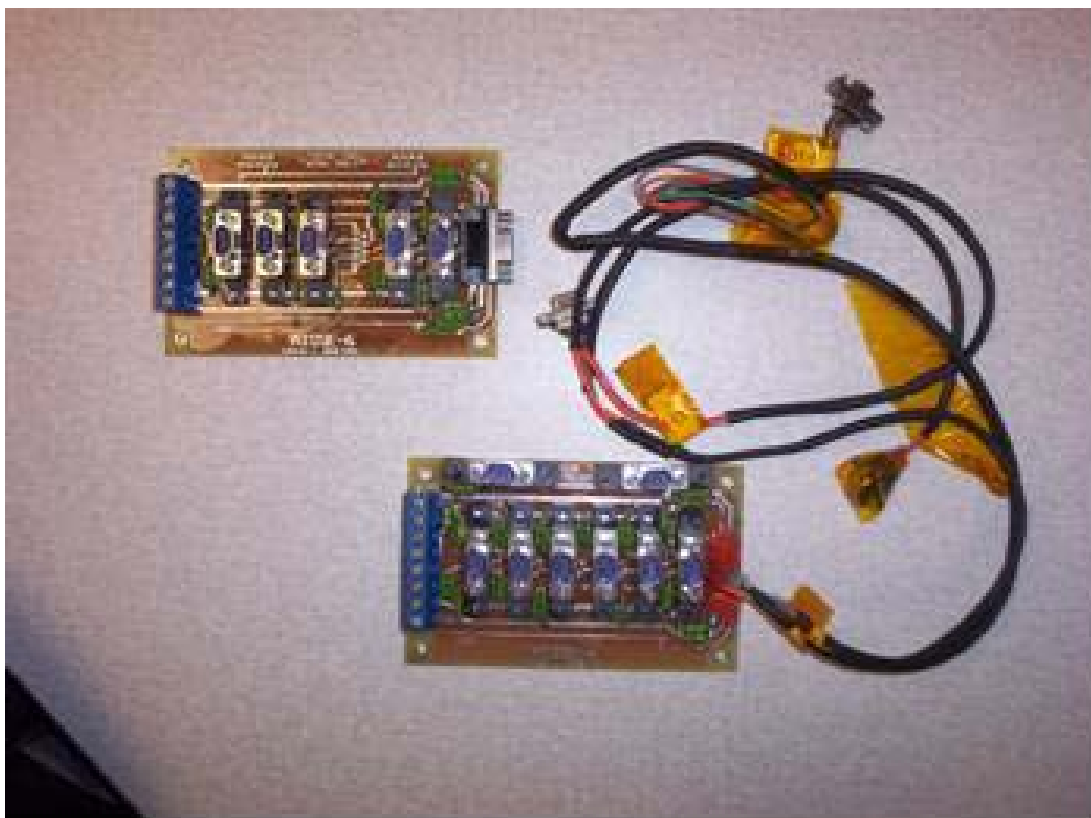
Figure A36: Post Flight Photos of 6B-UV (above) and 6B-AOUV (below) power distribution boards

During De-integration each individual power line from the 6B-UV power distribution board was visually inspected, photographed, and labeled. The power wiring and the power distribution boards were removed and shipped back to the Boeing Radiation Effects Lab. Continuity Checks were performed on all traces and fuses on the power distribution board and on all wiring. For 6B-UV the only anomaly discovered was omission of a fuse that should have connected +15V to slot 6. This oversight resulted in the NASA Glenn experiment G4 flying without +15V power. The lack of the +15V fuse on slot 6 was not detected pre-flight because no functional checks of the G4 experiment was conducted after being integrated onto MISSE-6.

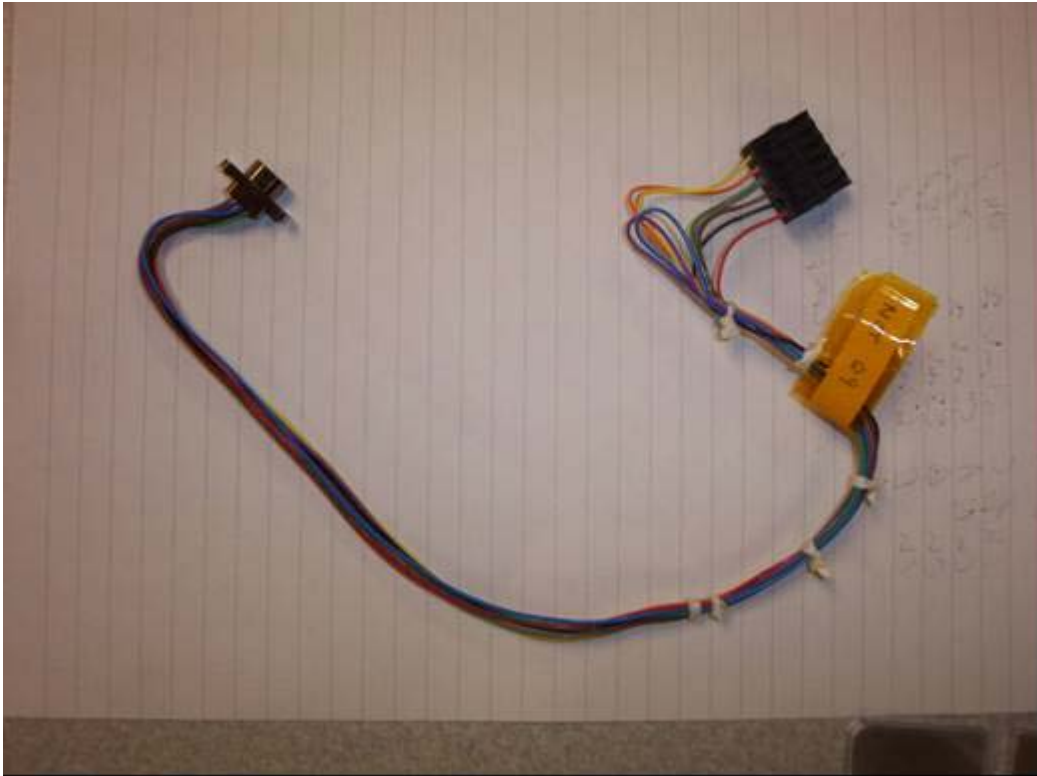
The data wiring for the Boeing experiments including QCMs and Rotor/Sensor were labeled, removed, and several of the wire bundles were shipped back to Boeing for post flight inspections. Inspections were conducted at Boeing on Data wiring for Q7, Q8, Q9 and the rotor-sensor. Results showed that Q7 and Q8 were properly wired to their data loggers.

Figure A42: the properly wired data interface for a QCM

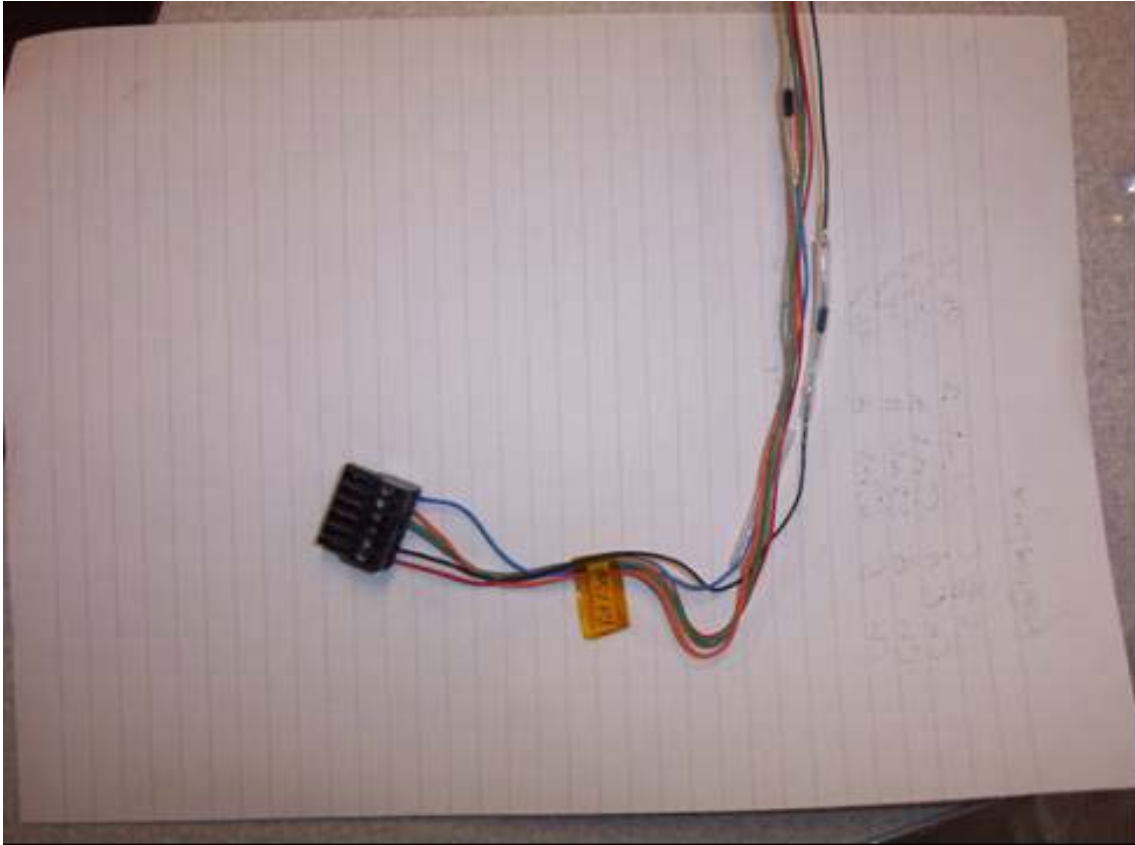
In addition, Q9 was properly wired into datalogger D8, and the rotor sensor was properly wired into datalogger D9. Datalogger D9 was a SP-4000-4CW, a current sensing datalogger, channel 1 of the data logger was connected through a 1kOhm resistor to the black data wire from the rotor. Channel 2 of D9 was unpopulated. Channel 3 was connected to the orange wire from the rotor. Channel 4 was connected through a 10KOhm resistor to the blue wire from the rotor connector.

Figure A436: Rotor wiring to D9
